Home Sweet Home Inspections

Home Inspection Report

811 Lake Village, Northport AL 35473

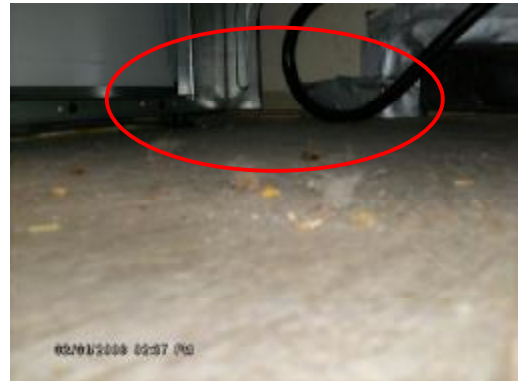
Safety Concern The anti-tip bracket that prevents the range from tipping over is not installed. The bracket should be installed to prevent the possibility of injury. See the manufacturer's installation instructions for details.

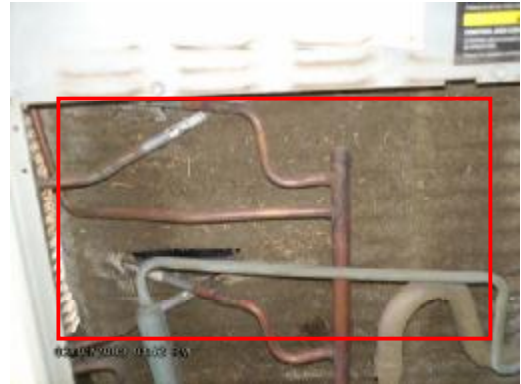
Coils in the condensing unit and air handler were examined and found to be in need of cleaning. The condensing unit coil is dirty and clogged limiting airflow. The air handler coil is dirty and clogged. This affects the operation of the system.

Minor Repair The failure probability of this system is moderate due to the age of the system. The coil in the outdoor A/C condensing unit is clogged with dirt and debris. This is not simply a maintenance issue. The dirty coil reduces heat transfer which affects the operation of the coil and the entire system. Cleaning of the coil is needed to restore the system to functional condition.

Minor Repair The evaporator coil in the air handler is dirty. This dirt may contain mold, fungus or other substances. A contractor should clean the coil. The inside of the air handler should also be cleaned. The dirty coil reduces heat transfer and affects the operation of the system.

Minor Repair The coil in the outdoor A/C condensing unit is clogged with dirt and debris. This is not simply a maintenance issue. The dirty coil reduces heat transfer which affects the operation of the coil and the entire system. Cleaning of the coil is needed to restore the system to functional condition.

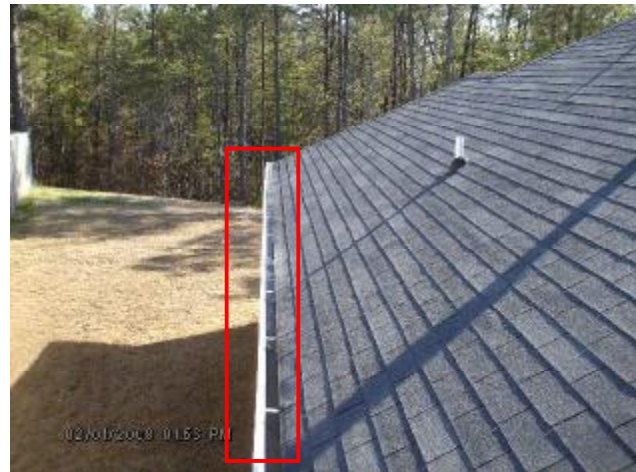
Minor Repair The gutters are improperly sloped allowing water to collect without draining away. This can be corrected fairly easily by rehangng them.

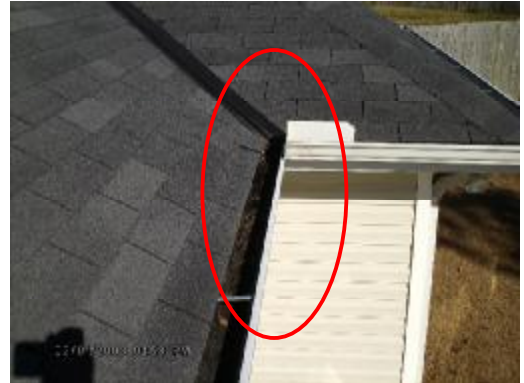
Maintenance The gutters are clogged with leaves and debris. They need to be cleaned out.

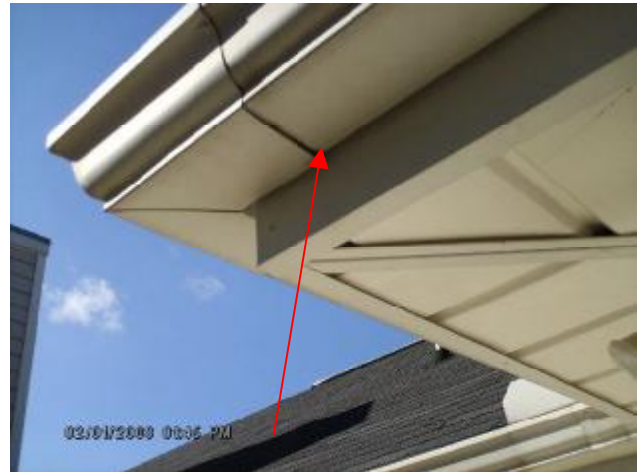
Minor Repair There are places the gutters are leaking.

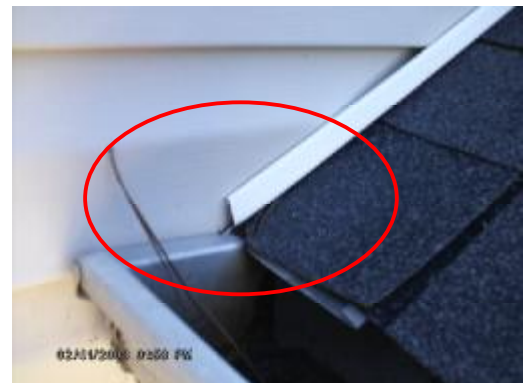
Minor Repair No “kickouts” were installed at the lower ends of sidewall flashings. The lack of kickouts allows water to flow beneath the siding. This will lead to damage. Kickout flashings should be installed at the lower ends of all sidewall flashings.

Minor Repair No “kickouts” were installed at the lower ends of sidewall flashings. The lack of kickouts allows water to flow beneath the siding. This will lead to damage. Kickout flashings should be installed at the lower ends of all sidewall flashings. At the roof to wall connections rake flashing is being used instead of step flashing.

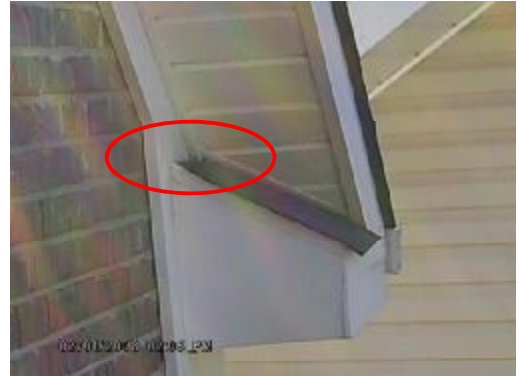
Major Repair There is no flashing at the roof to wall connections at the gable returns. This can let water get in and cause damage (2)

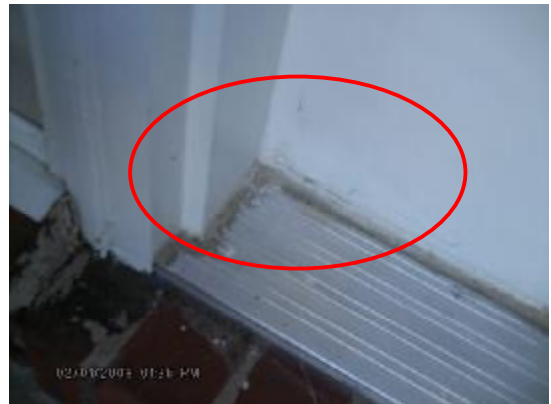
Minor Repair Cosmetic rot was observed in the bottom of the jamb or trim at the exterior of the front door. This can be repaired by replacing rotted sections or digging out rotted areas and filling them with various patching materials.

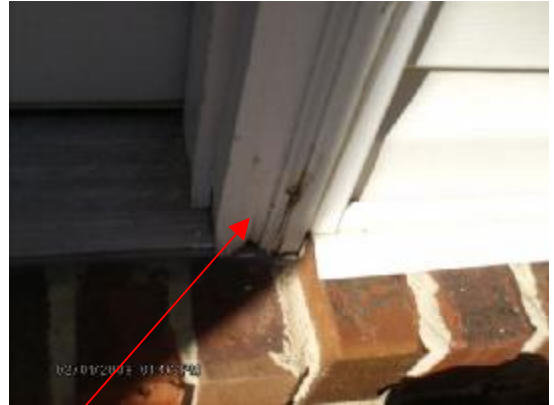
Minor Repair Cosmetic rot was observed in the bottom of the jamb or trim at the exterior of the back door. This can be repaired by replacing rotted sections or digging out rotted areas and filling them with various patching materials.

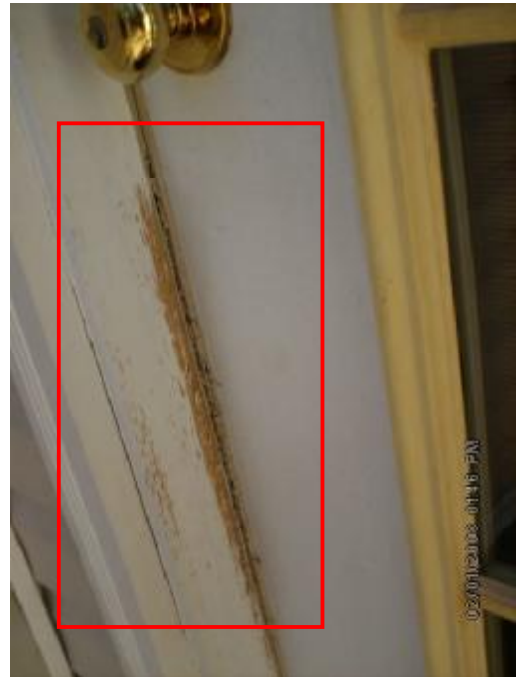
Minor Repair There is damage to the wood trim and weather striping at the rear door that was caused by a pet.

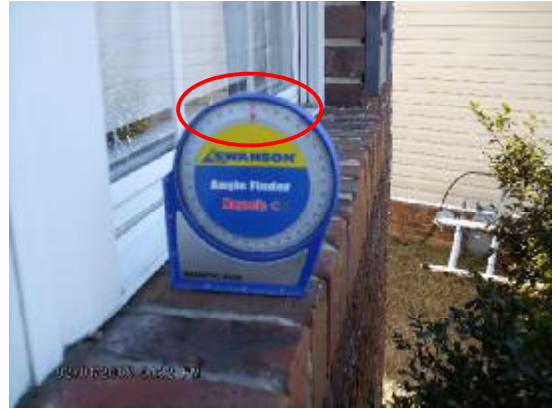
Minor Repair There are areas at the windows where the bricks are sloping wrong. Slopping backer or not enough slope (less than 15 degree). This can be letting water into the interior walls. The area that was seen is at the front of the house. There could be other places.

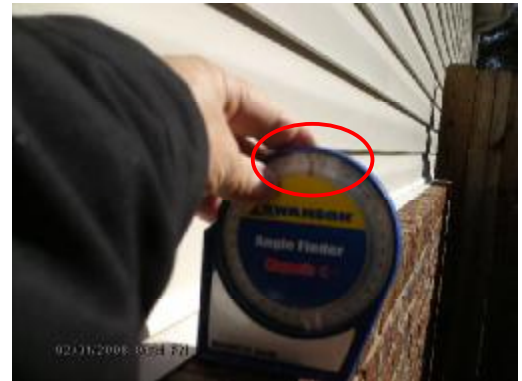
Minor Repair There are areas at the brick rowlock that the bricks are sloping wrong. Slopping backer or not enough slope (less than 15 degree). This can be letting water get behind the bricks.

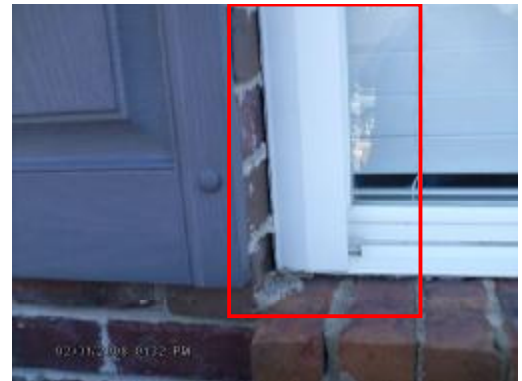
Minor Repair There are some windows that need to be caulked around to help keep moisture out from getting behind the siding. The one(s) that was seen are in the brick siding.

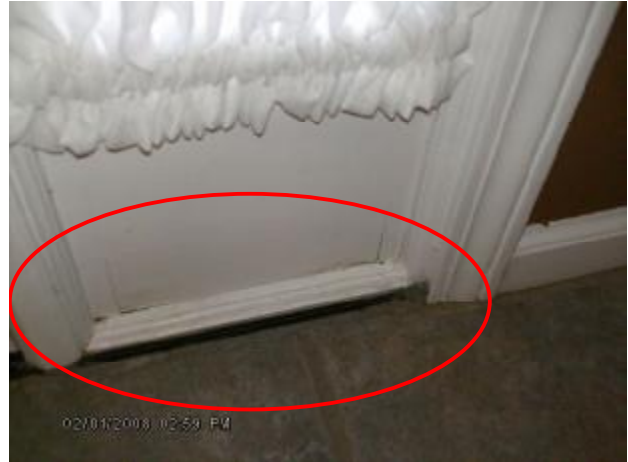
Minor Repair There is or has been water getting in at the exterior door(s) and causing damage. The ones that where seen is at the front door.

Minor Repair There is or has been water getting in at the exterior door(s) and causing damage. The ones that were seen is at the front door.

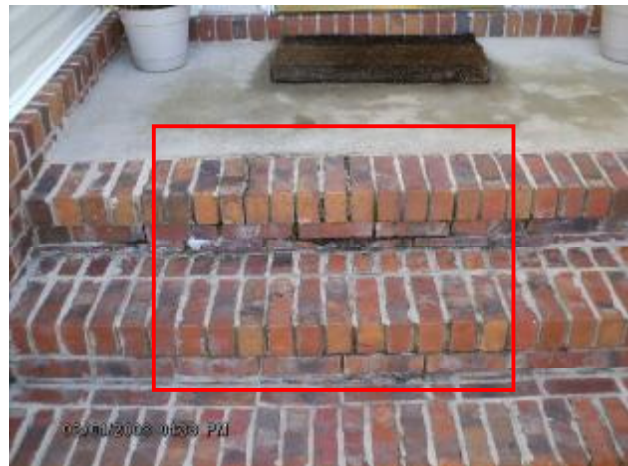
Maintenance The mortar has washed out from between some of the bricks on the exterior steps. They should be repaired.

Maintenance There is a built up of moss on the steps that need cleaned off. The mortar has washed out from between some of the bricks on the exterior steps. They should be repaired.
