**Home Sweet Home Inspections**  
**P.O. Box 99 Samantha, AL 35482**

## Condominium Inspection Report Sample

Prepared For:  
Condominium  
Buyer

Address: 106 Condominium, Tuscaloosa AL

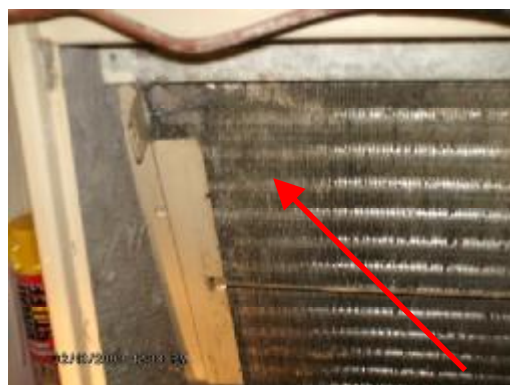
Coils in the condensing unit and air handler were examined and found to be in need of cleaning. The air handler coil is dirty and clogged. This affects the operation of the system.

**Minor Repair** The evaporator coil in the air handler is dirty. This dirt may contain mold, fungus or other substances. A contractor should clean the coil. The inside of the air handler should also be cleaned. The dirty coil reduces heat transfer and affects the operation of the system.

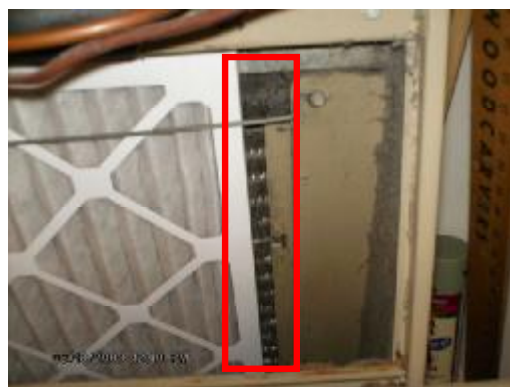
**Minor Repair** The air handler does not have an auxiliary drain pan beneath it. Auxiliary drain pans are required to prevent the damage to the ceilings and walls beneath the unit that will occur when the main drain becomes clogged. It is just a matter of time until this damage occurs as these drains inevitably become clogged, especially when service is neglected. The installation of a drain pan is needed. Have a contractor install a drain pan.

**Minor Repair** The air filters were the wrong size. This is letting unfiltered air get to the coils and causing a built up on them. Recommend cleaning the coils, servicing the cooling system and checking the refrigerant level

**Minor Repair** The attic air handler does not have an auxiliary drain pan beneath it. Auxiliary drain pans are required to prevent the damage to the ceilings and walls beneath the unit that will occur when the main drain becomes clogged. It is just a matter of time until this damage occurs as these drains inevitably become clogged, especially when service is neglected. The installation of a drain pan is needed. Have a contractor install a drain pan.

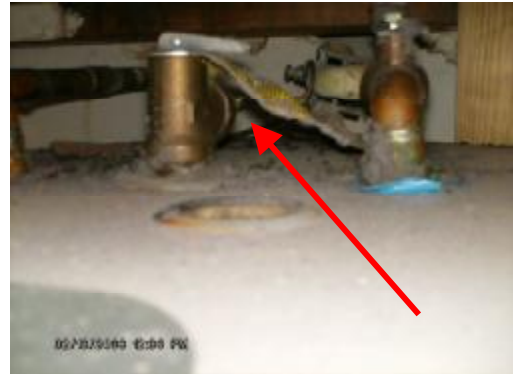
**Safety Concern** Piping from the water heater temperature/pressure relief valve should be extended to within 12" of the floor. In the event the water heater controls became defective and failed to stop heating, the steam and boiling hot water discharged would strike anyone standing nearby. Extension piping is required to be the same size as the valve. It may not be reduced. See the manufacturer's installation instructions for other requirements. Repair of this condition is inexpensive.

The water heater is not installed in a drain pan (as would be required in a new installation.) When it begins to leak, as all inevitably do, water will damage floor coverings.

**Minor Repair** The water heater is not installed in a drain pan (as would be required in a new installation.) When it begins to leak, as all inevitably do, water will damage floor coverings.

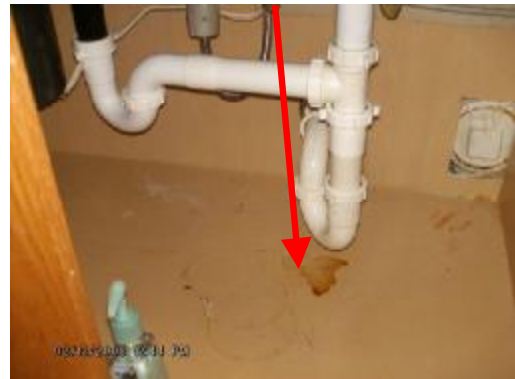
**Minor Repair** Minor leakage was observed from the drain piping beneath the kitchen sink.

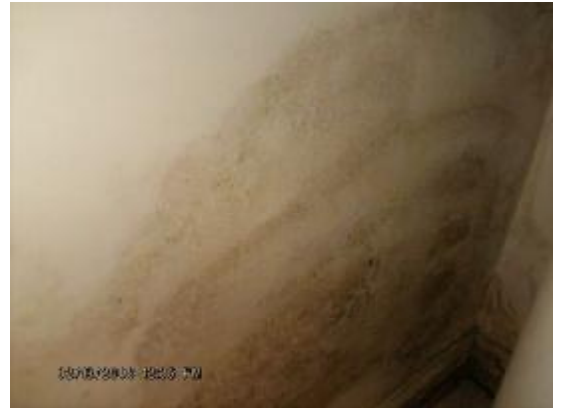
**Investigate Further** Interior cabinets were found to be in adequate condIn the utility room beside the water heater there are walls with fungus growth on them.

**Investigate Further** In the utility room beside the water heater there are walls with fungus growth on them.

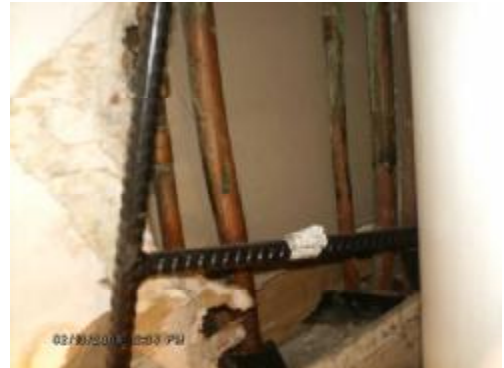
**Investigate Further** There is an area where the plumbing is showing behind the water heater where the wall has been torn out.

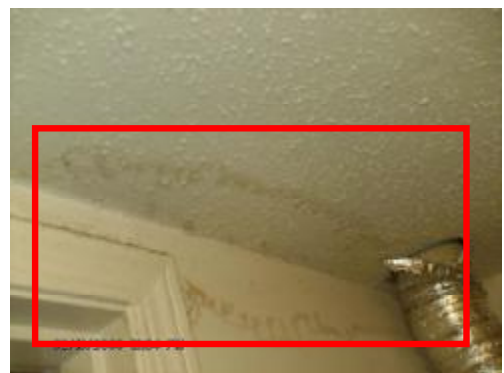
**Investigate Further** There are other stains on the walls and ceiling along with an repaired area

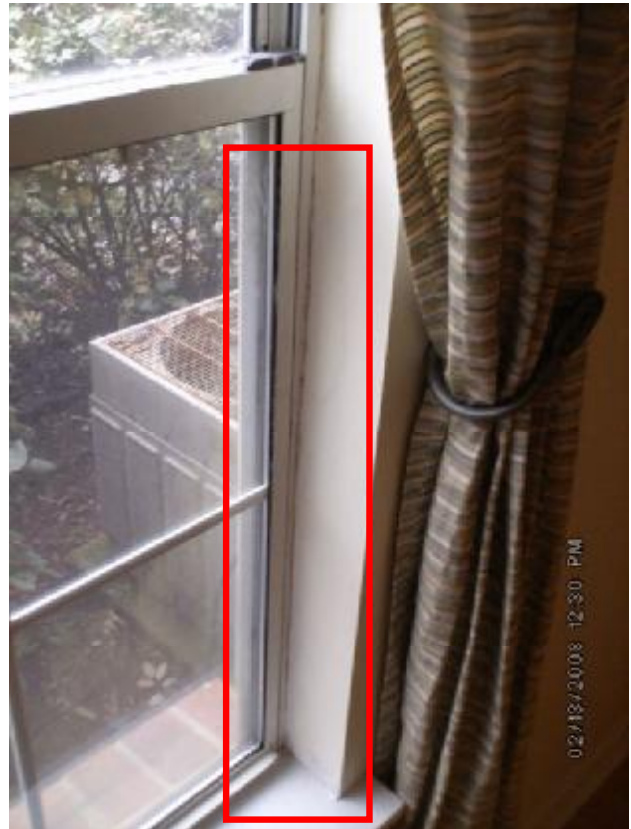
**Minor Repair** There are window that will not stay up when they are opened, the one(s) that where found is at the bedroom.

**Minor Repair** At the bedroom window there is moisture stains on the sheet rock.

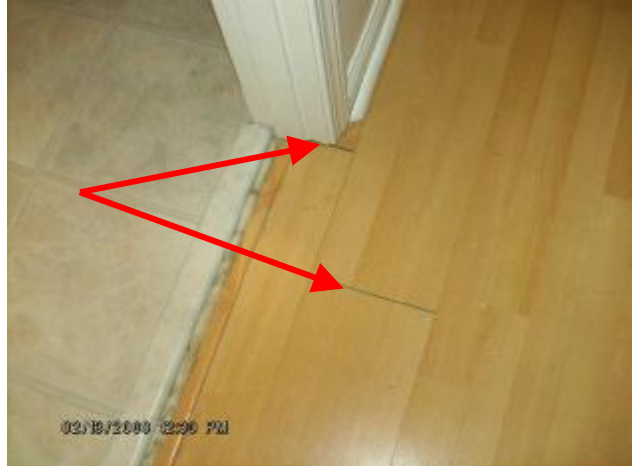
**FYI** There are joints in the wood flooring that is wider than normal.
