Home Sweet Home Inspections

New Home Inspection Report Sample

Report Number: 051508

Address: 10 Austin Drive Wood AI 35118

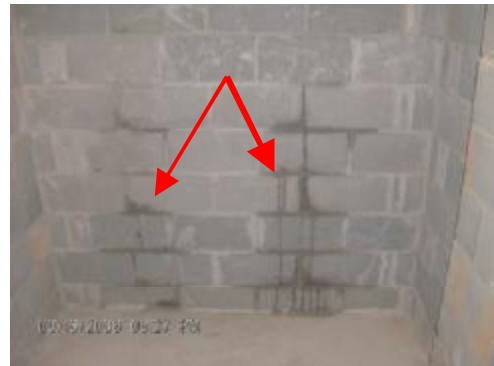
Investigate Further Evidence of water entry was observed in the basement. Often water entry problems can be reduced or cured with a few simple steps. Make sure the gutter down spouts carry water away from the building. The soil near the building should have a positive slope away from the building to carry away water. Be sure that no water can collect in window wells. These steps may help alleviate the problem, but this is not a certainty.

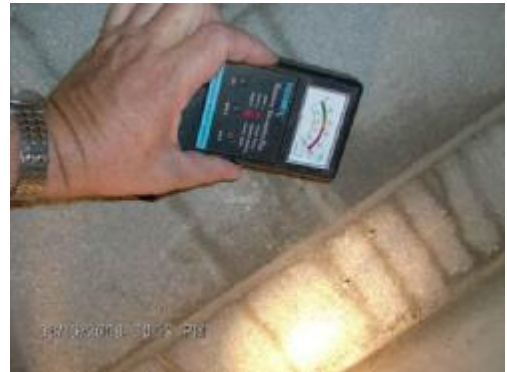
Investigate Further There is water getting in the basement under the front porch. There is a high moist reading in this area. Steps need to be taken to find out how the water is getting in, and then repair as needed.

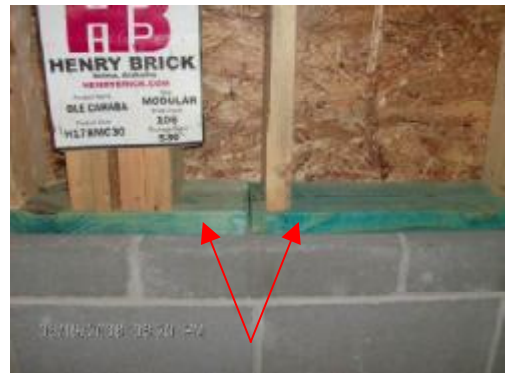
Investigate Further Some Anchor bolts/straps were noted in the raised foundation area. There are places where they are not installed, as they should. At the joints where the boards end and the next one begins.

R403.1.6 Foundation anchorage.

When braced wall panels are supported directly on continuous foundations, the wall wood sill plate or cold-formed steel bottom track shall be anchored to the foundation in accordance with this section.

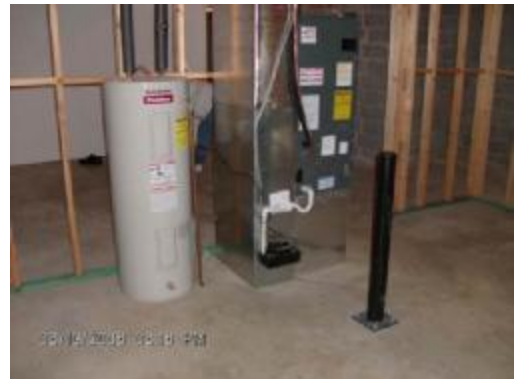
Safety Concern The water heater is installed in the garage. It needs to have a post or some type of protection installed in front of it so a car cannot make contact with it

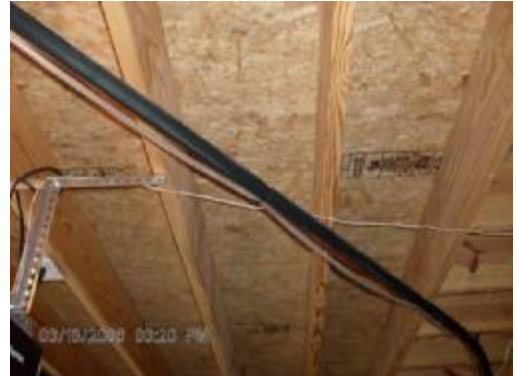
Safety Concern The ceiling above the garage and below the living space is missing its fire separation

R309.2 Separation required.

The garage shall be separated from the residence and its attic area by not less than ½-inch (12.7 mm) gypsum board applied to the garage side. **Garages beneath habitable rooms shall be separated from all habitable rooms above by not less than 5/8-inch (15.9 mm) Type X gypsum board or equivalent.** Where the separation is a floor-ceiling assembly, the structure supporting the separation shall also be protected by not less than ½-inch (12.7 mm) gypsum board or equivalent.

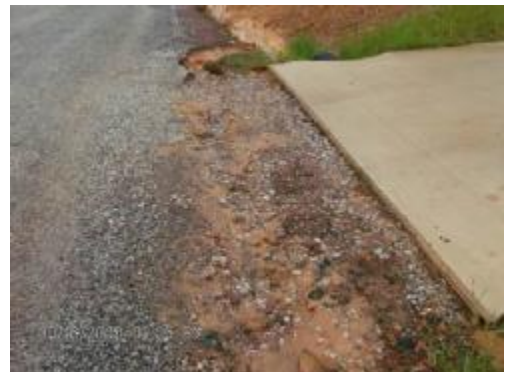
Investigate Further Where the drive way connects to the road there are places that are washing away. These areas need to be repaired.

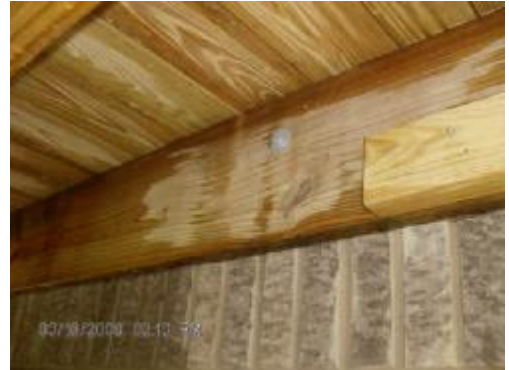
Investigate Further There is no flashing installed where the deck connects to the house. The flashing is supposed to be here is to protect the wall from water getting in and causing damage to the framing the deck is connected to.

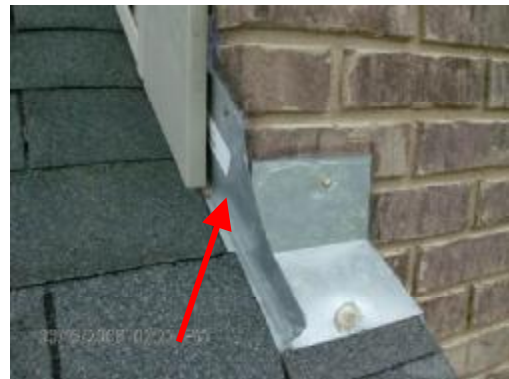
Minor Repair The gutters are improperly sloped allowing water to collect without draining away. This can be corrected fairly easily by rehanging them. The main area is at the rear of the house.

Minor Repair Nails or staples were observed that are "popping", or rising up out of the wood deck. Eventually, these will wear small holes through the shingles that they are pressing up into. These need to be nailed back down into place. This is a common condition, and it may reoccur in the future. Any shingles with holes worn through are considered leaks. These should be repaired.

Investigate Further At the roof to wall connections rake flashing is being used instead of step flashing.

(International Residential Code R905.2.8.4 Sidewall flashing. Flashing against a vertical sidewall shall be by the step-flashing method).

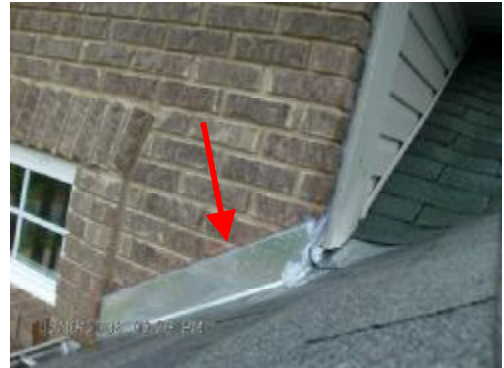
Investigate Further There is no counter flashing installed at the flashing at the roof to wall connections at the front of the house. This could be letting water get behind the flashing

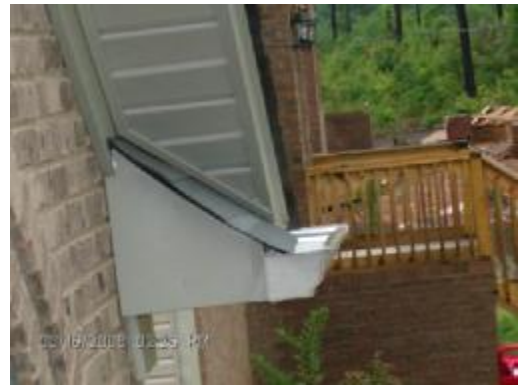
Minor Repair There is no roof to wall flashing installed at the gable roof returns

R905.2.8.5 Other flashing.

Flashing against a vertical front wall, as well as soil stack, vent pipe and chimney flashing, shall be applied according to asphalt shingle manufacturer's printed instructions.

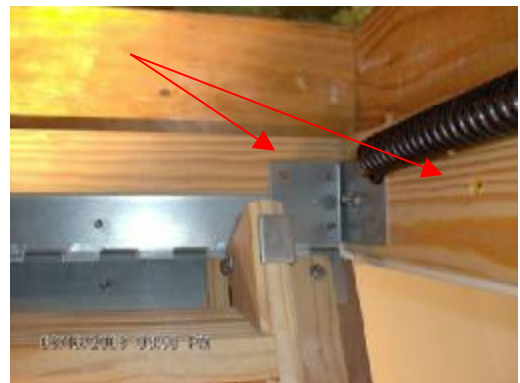
Safety Concern The attic pull down stairway is unsafe; it is installed with screws. It is suppose to be installed with nails or bolts. The manufacturer's instructions recommend 16-penny nails or 1/4" x 3" bolts.

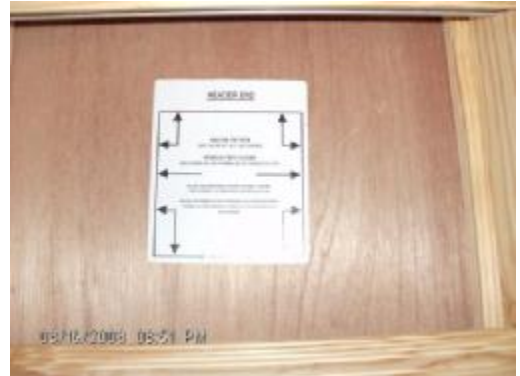
Safety Concern Label how access is to be fastened.

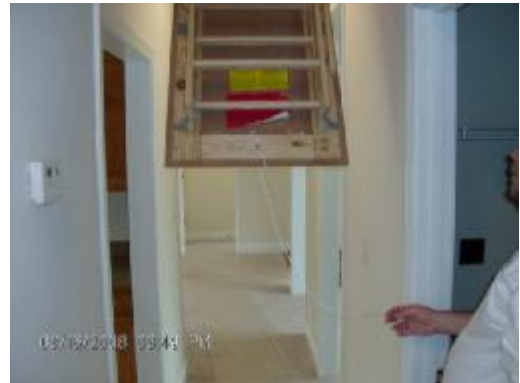
Safety Concern The attic access needs to be turn around so it would be easier to get into the attic when some one needs to work in the attic or a fireman needs to put out a fire if there was one.

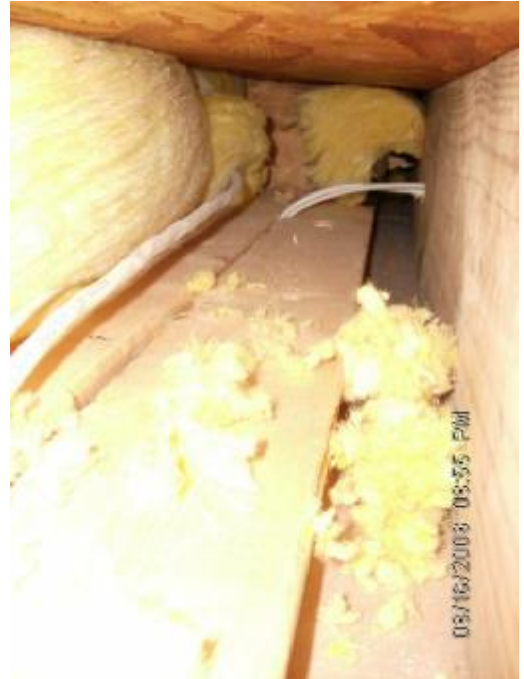
Minor Repair Attic pull down stairs should have insulation added to it to help keep the condition air from getting into the attic.

Minor Repair There are areas that the insulation is missing. This is under some of the wood flooring in the attic

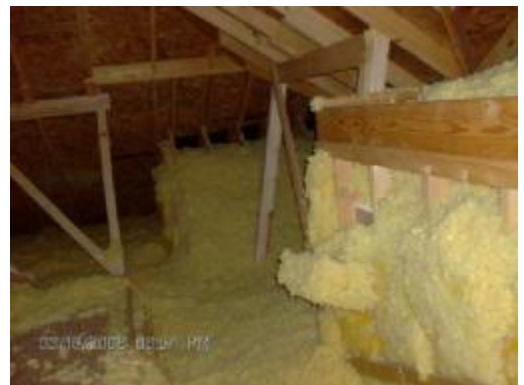
Minor Repair There is insulation that has been knocked down at the raised interior wall in the attic. This needs to be installed back in place.

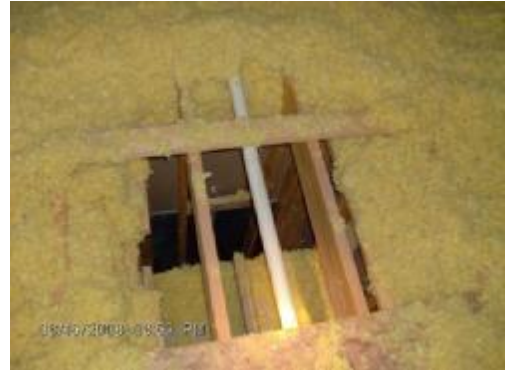
Investigate Further There are areas that the dry wall is missing in the ceiling. This is in the attic. The backside of the interior wall can be seen. The drywall needs to be installed and covered with insulation or the interior wall needs insulation to keep the condition air from getting into the attic

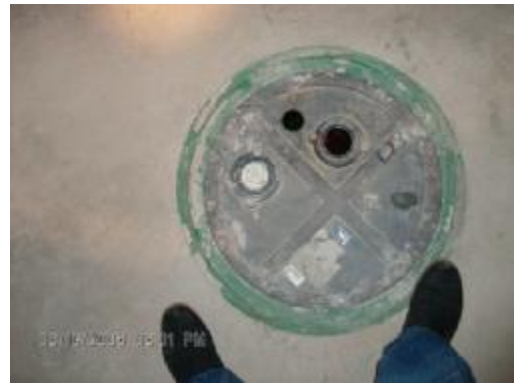
Investigate Further In the basement there is a pit for a pump for the bathroom that has not been installed. This pit is holding water and has cans and trash in it. There should not be water in the pit since it not tied into the plumbing. The water may be coming in from underground. If it is it could cause the basement to have water come in and cover the floor and cause damage. A pump needs to be installed

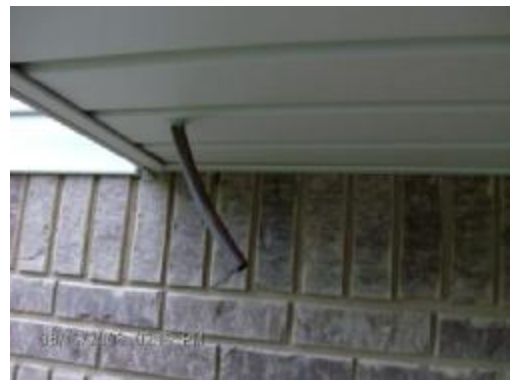
Investigate Further The gas tank and line has not been installed for the gas logs. The logs were not tested. The tank needs to be installed along with the rest of the gas line.

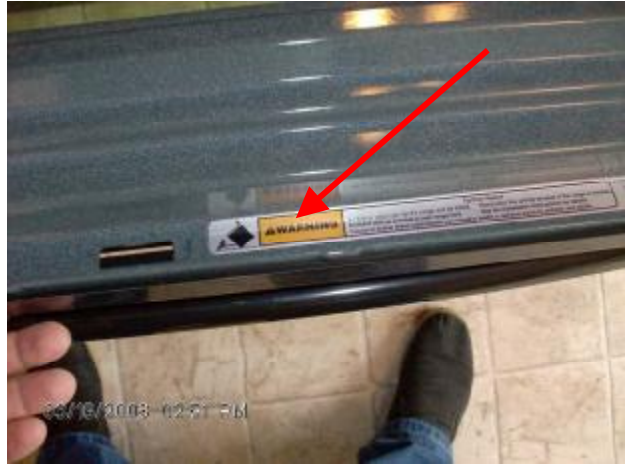
Safety Concern The anti-tip bracket that prevents the range from tipping over is not installed. The bracket should be installed to prevent the possibility of injury. See the manufacturer's installation instructions for details.

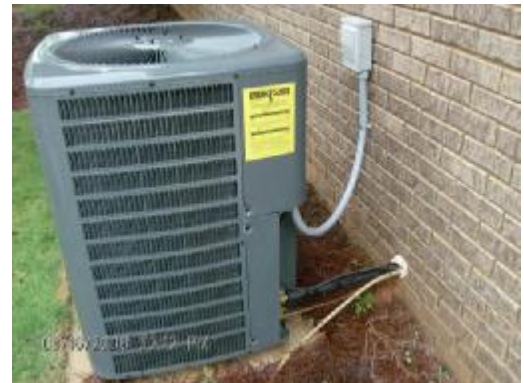
Safety Concern The exterior units of the heating and cooling units are in front of the electrical disconnect(s). The electrical disconnect(s) are to have clear working space in front of them.

E3305.1 Working space and clearances.

Sufficient access and working space shall be provided and maintained around all electrical equipment to permit ready and safe operation and maintenance of such equipment in accordance with this section and Figure E3305.1.

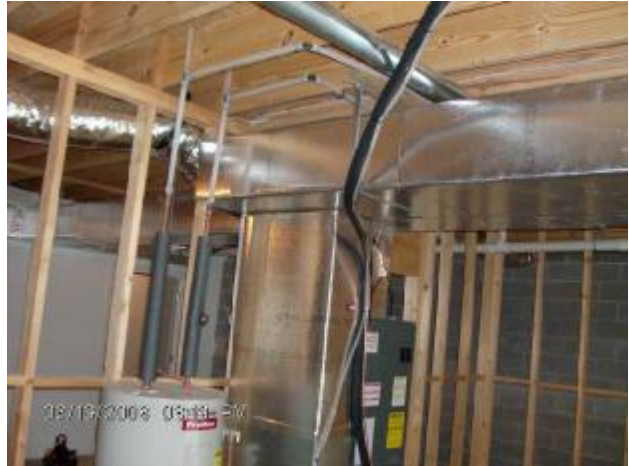
Safety Concern There is no electrical disconnect for the heat pump, to shut the power off when they are being worked on. [IRC 3305]

Safety Concern There is no electrical disconnect for the water heater(s) or lock out for the breaker at the electrical panel, to shut the power off when they are being worked on.

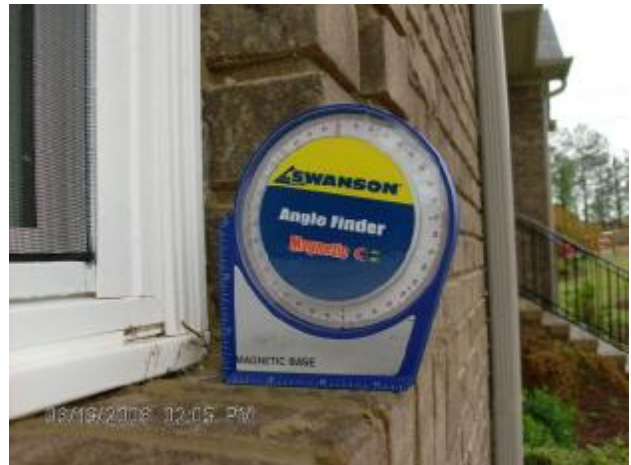
Investigate Further *There are no weep holes or flashing visible in the brick veneer as recommended by "the Brick Industry Association" (www.bia.org) and Modern building standards This is to let any water out from behind the bricks. Water that is trapped behind the brick against exposed wood could cause decay. This is supposed to be at the windows, above the garage door and other areas. (International Residential Code 2003 Section 703.)*

R703.7.5 Flashing.

1. At top of all exterior window and door openings in such a manner as to be leakproof, except that self-flashing windows having a continuous lap of not less than 1 1/8 inches (28 mm) over the sheathing material around the perimeter of the opening, including corners, do not require additional flashing; jamb flashing may also be omitted when specifically approved by the building official.
2. At the intersection of chimneys or other masonry construction with frame or stucco walls, with projecting lips on both sides under stucco copings.
3. Under and at the ends of masonry, wood or metal copings and sills.
4. Continuously above all projecting wood trim.
5. Where exterior porches, decks or stairs attach to a wall or floor assembly of wood-frame construction.
6. At wall and roof intersections.
7. At built-in gutters.

Investigate Further There are areas at the windows brick rowlock that the bricks are sloping wrong. Slopping backer or not enough slope (less than 15 degree). This can be letting water get behind the bricks.

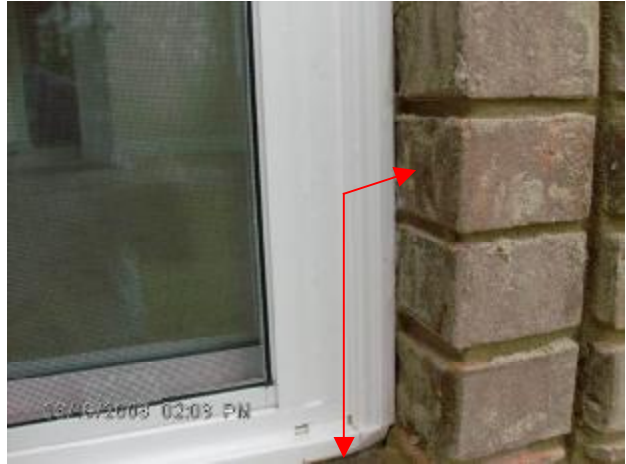
Minor Repair There are some windows that need to be caulked around to help keep moisture out from getting behind the siding.

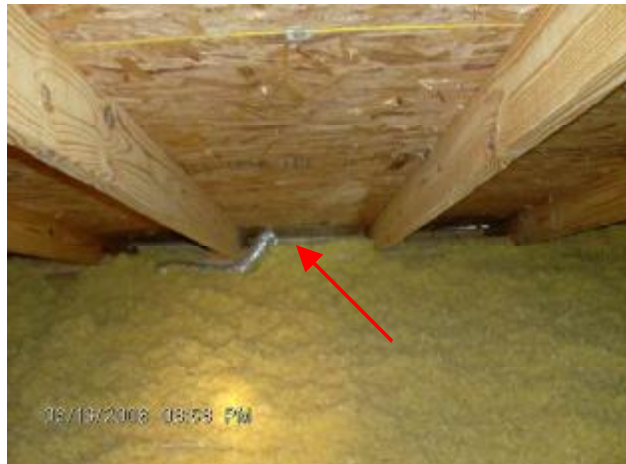
Minor Repair The bathroom exhaust fans are vented to the soffits. They are supposed to be vented to the exterior. Manufacture installment instructions, International Residential Code 303.3 and United Mechanical Code 504]

R303.3 Bathrooms.

Bathrooms, water closet compartments and other similar rooms shall be provided with aggregate glazing area in windows of not less than 3 square feet (0.279 m²), one-half of which must be operable.

Exception: The glazed areas shall not be required where artificial light and a mechanical ventilation system are provided. The minimum ventilation rates shall be 50 cfm (23.6 L/s) for intermittent ventilation or 20 cfm (9.4 L/s) for continuous ventilation. **Ventilation air from the space shall be exhausted directly to the outside.**
