Home Sweet Home Inspections

Sellers Home Inspection Report Sample

Report Number: 050608A

Address: 1625 Creek Drive Mudville Al. 35470

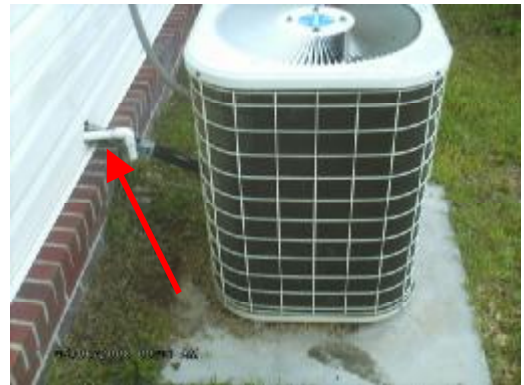
Minor Repair The opening around the pipes and wires should be sealed to keep water from getting in behind the siding. (2) The areas seen are gas meter and AC lines. There could be other areas.

Minor Repair The opening around the pipes and wires should be sealed to keep water from getting in behind the siding. The areas seen are gas meter and AC lines. There could be other areas.

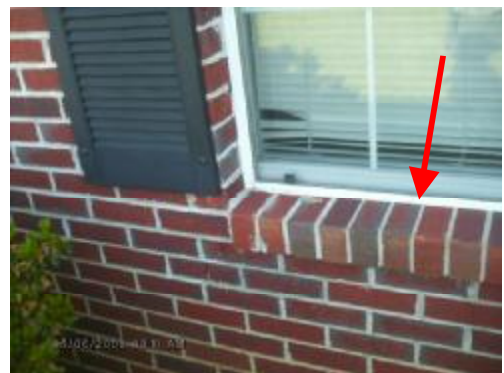
Investigate Further There are areas at the windows brick rowlock that the bricks are sloping wrong. Sloping backer or not enough slope (less than 15 degree). This can be letting water get behind the bricks. The windows need to be kept caulked at these areas.

Investigate Further There are areas at the windows brick rowlock that the bricks are sloping wrong. Slopping backer or not enough slope (less than 15 degree). This can be letting water get behind the bricks. The windows need to be kept caulked at these areas.

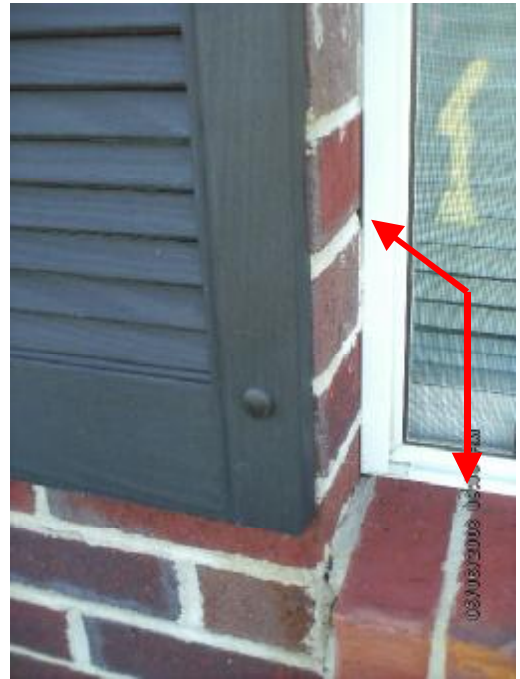
Minor Repair There are some windows that need to be caulked around to help keep moisture out from getting behind the siding. The one(s) that was seen are in the brick siding.

Minor Repair There are some windows and doors that need to be caulked around to help keep moisture out from getting behind the siding. The one(s) that was seen are in the brick siding.

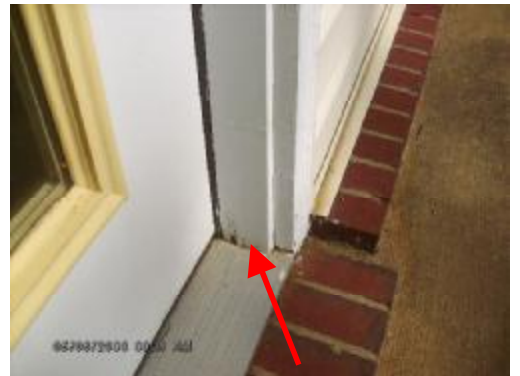
Minor Repair Cosmetic rot was observed in the bottom of the jamb or trim at the exterior of the back door. This can be repaired by replacing rotted sections or digging out rotted areas and filling them with various patching materials.

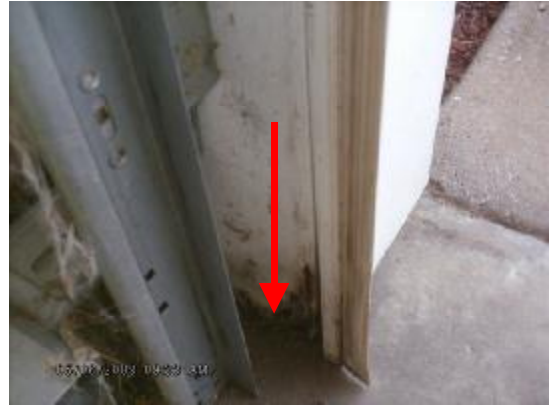
Minor Repair Cosmetic rot was observed in the bottom of the jamb or trim at the interior of the garage door. This can be repaired by replacing rotted sections or digging out rotted areas and filling them with various patching materials.

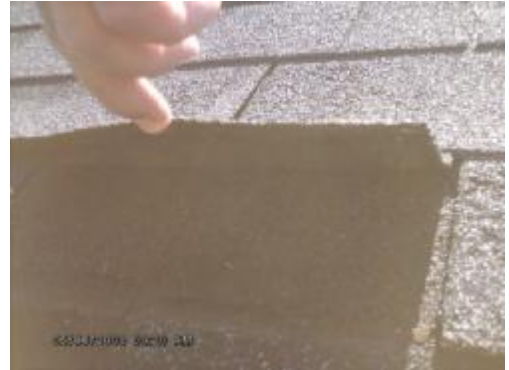
Investigate Further There are areas that the shingles are not bonded/stuck to each other. They should be sealed down so the wind cannot get under them and be blown off.

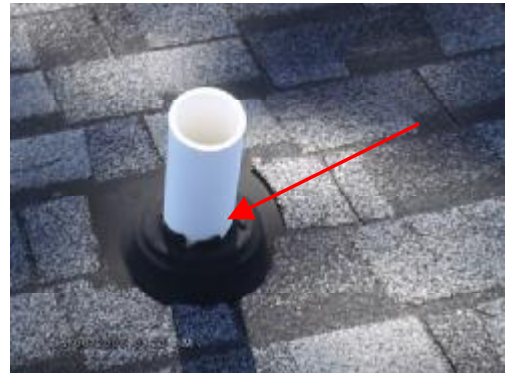
Minor Repair Separations were noted in the exposed flashing at the plumbing vent pipes. They need to be repaired/replaced to help keep water out of the attic.

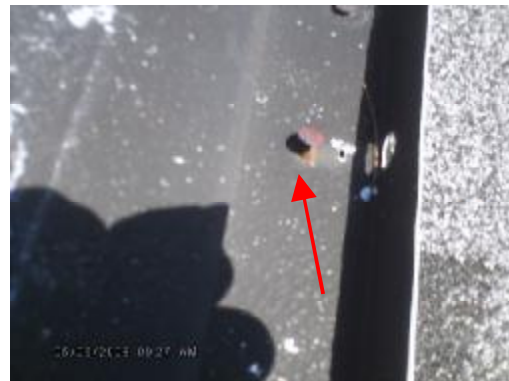
Minor Repair Some of the ridge vents are loose and should be installed back in place to keep water from getting in.

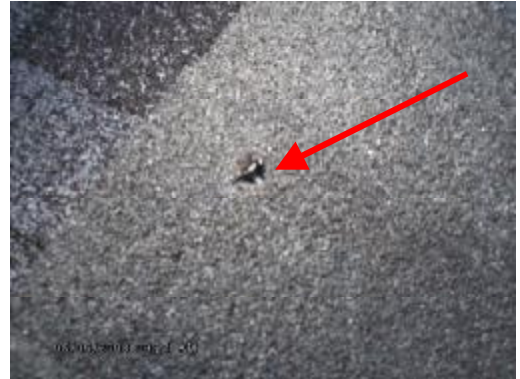
Minor Repair There are areas that nails are backing out of the shingles. This is causing opening that could let water to get under the roofing and into the attic. The places that where seen is at the right side ridge of the roof.

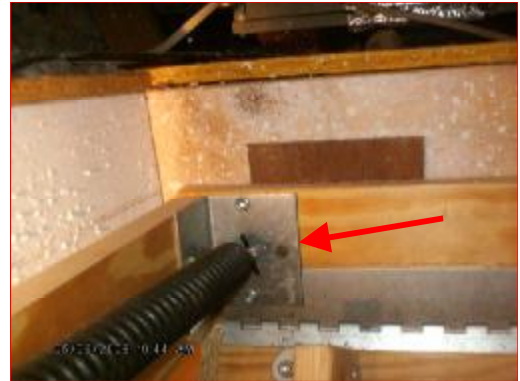
Safety Concern The attic pull down ladder is installed in an unsafe manner. Attic access is installed with drywall screws. It is suppose to be installed with nails. (2) (4). The manufacturer's instructions recommend 16-penny nails or 1/4" bolts. **DO NOT USE THE LADDER UNTIL IT CAN BE MADE SAFE.**

Safety Concern The attic pull down ladder is installed in an unsafe manner. Attic access is installed with drywall screws. It is suppose to be installed with nails. The manufacturer's instructions recommend 16-penny nails or 1/4" bolts. **DO NOT USE THE LADDER UNTIL IT CAN BE MADE SAFE.**

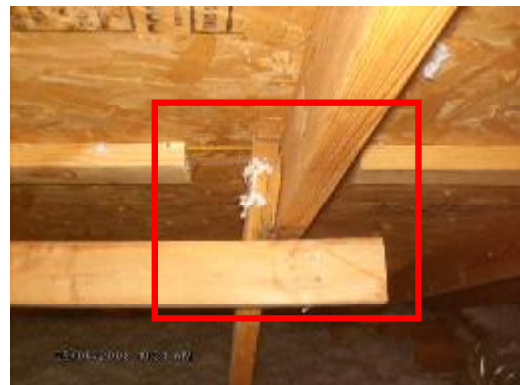
Minor Repair The attic framing system has been altered/cut. This needs to be repaired since it supports the roof.

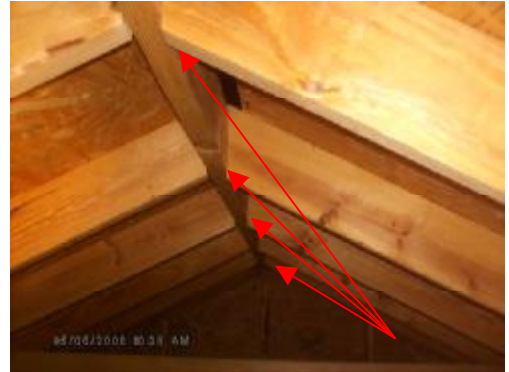
Investigate Further The ridge board for the attic framing is to small. It is suppose to be at least as large as the cut angle on the roof rafters. Adding a 2 X 2 to the bottom of the ridge board is one repair that could be done..

Investigate Further The ridge board for the attic framing is too small. It is suppose to be at least as large as the cut angle on the roof rafters. Adding a 2 X 2 to the bottom of the ridge board is one repair that could be done..

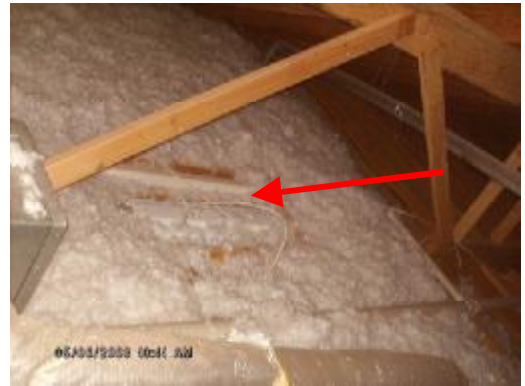
Minor Repair The insulation in the attic is improperly covering the recessed light fixtures. This condition may cause the light fixtures to overheat. The insulation needs to be moved off of the lights

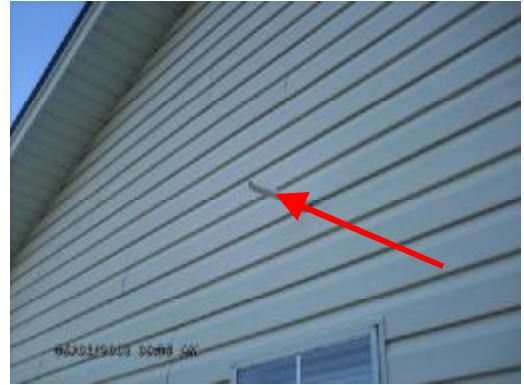
Minor Repair The auxiliary drain line on the exterior of the house is sloped where the water will drain back to the house. An elbow needs to be install so the water will drip downward..

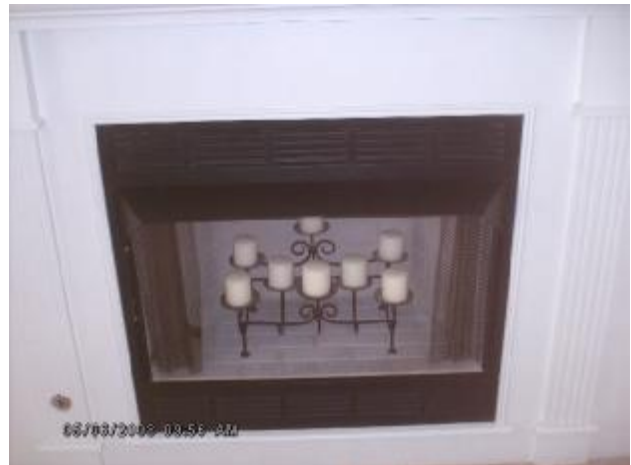
Minor Repair There are no gas logs installed in the fireplace. The type of fireplace can only use gas logs.

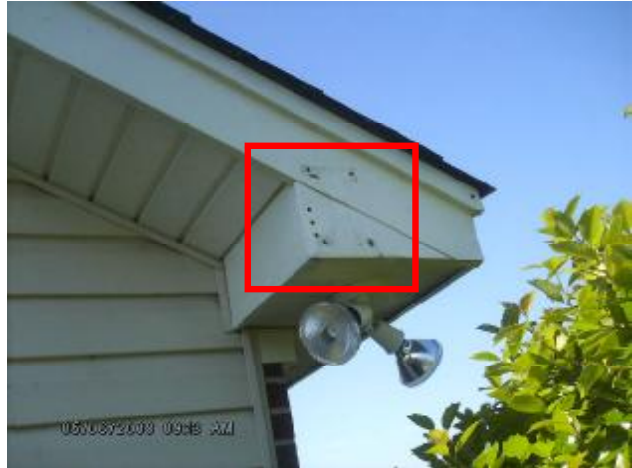
More areas that needs to be sealed.
