Home Sweet Home Inspections

Building Inspection Report

Prepared For:
Small
Commercial
Office

Address: 1205 1st Street South AL.

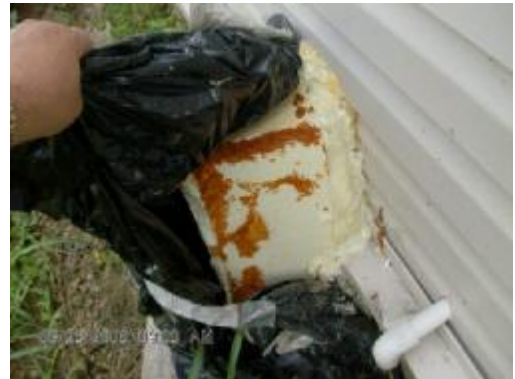
Investigate Further At the wall where the water supply pipe come into the building the pipe are covered with foam and plastic. These in time will deteriorate in the sun. It is also blocking some of the drainage.

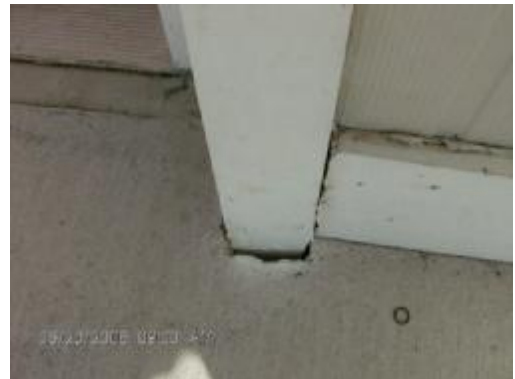
Investigate Further At the front of the building the trim and siding is run below the concrete of the side walk. This will cause moisture to get to the siding and give termites a pathway to get in.

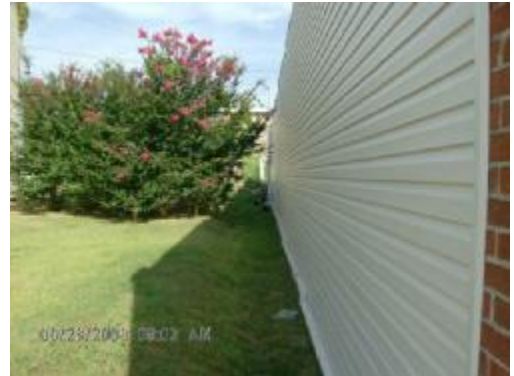
Investigate Further The drainage at the left side of the building is carrying a lot of water. There are places that the drainage does not slope properly; there are items that block the flow of the water and places the water is getting next to the building. Adjust needs to be made or other type of drainage needs to be installed.

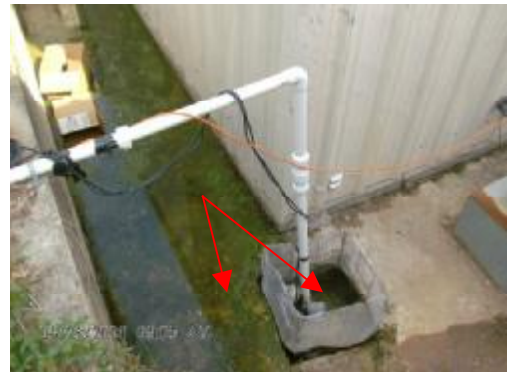
Investigate Further The sump pump at the rear of the building needs to be in a deeper hole where it will come on before the water has completely full up the pit and is overflowing.

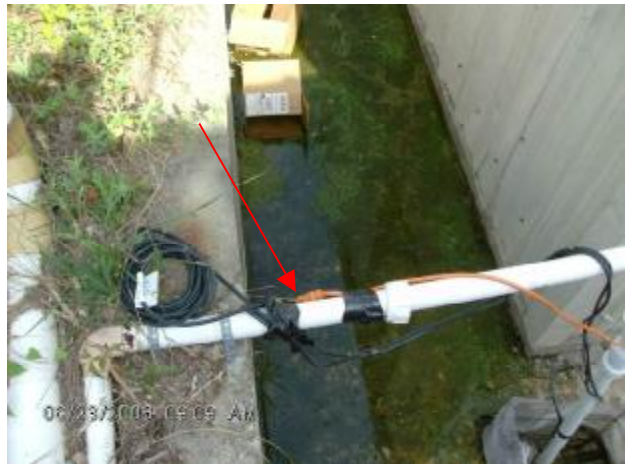
Investigate Further The sump pump at the rear of the building is on an extension cord. It needs to be on permanent wiring. This pump will not work when the power is off from a storm.

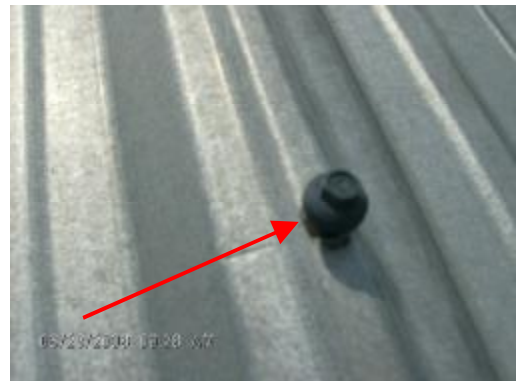
Minor Repair There are areas that the screws are backing out of the metal roof. This is causing opening that could let water to get under the roofing and into the attic

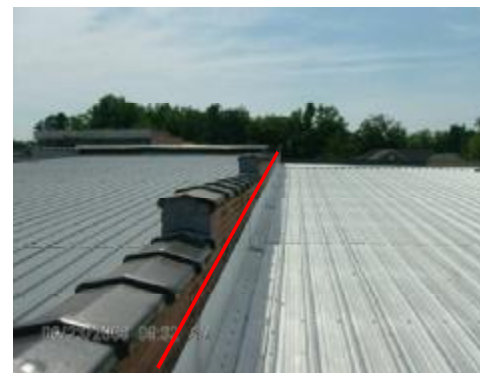
Investigate Further There is no counter flashing installed at the flashing at the roof to wall connections at the building next door. This could be letting water get behind the flashing

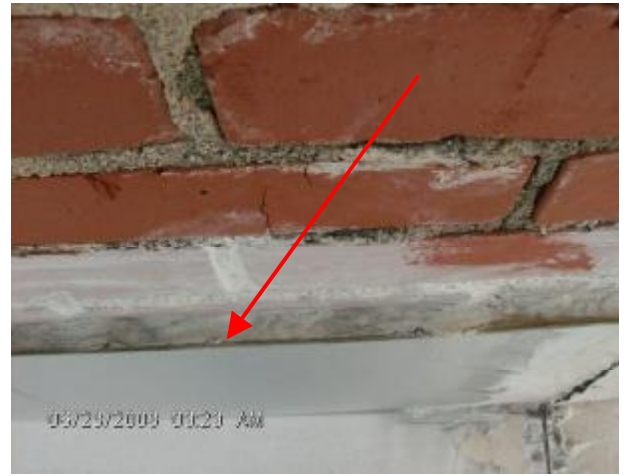
Minor Repair At the caulk joints in the flashing at the roof to wall connections the caulking is cracking open. This could be letting water get behind the flashing

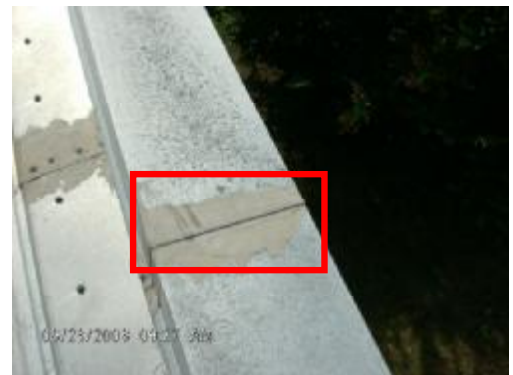
Investigate Further The seams/joints in the metal coping on top of the wall is installed with flat overlapping joints that is sealed with caulk. It time these joints will crack open and have to be resealed. If they had been installed with a standing seam this would not be a problem.

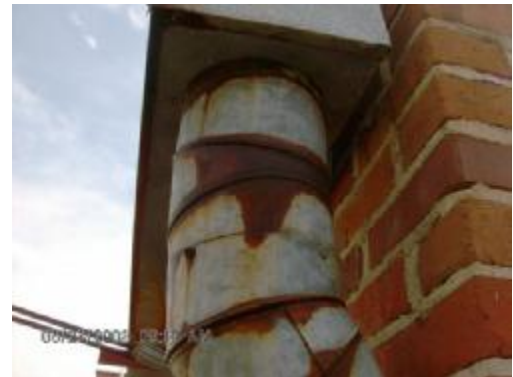
Investigate Further The gutter and downspout is rusting and leaking. Repair/replaces is needed.

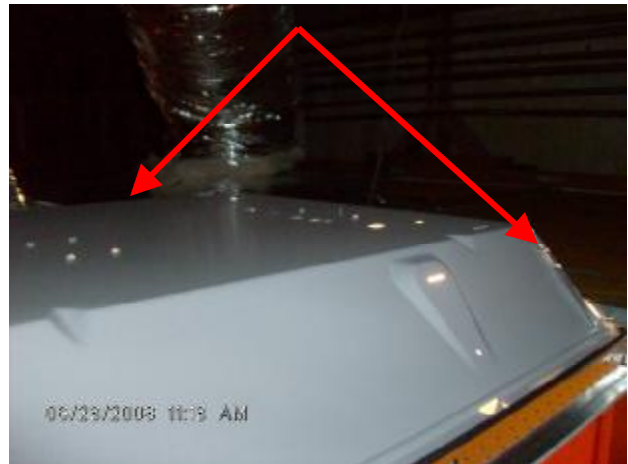
Safety Concern The lights that are installed in the lay in ceiling are supposed to have support wire installed on them. This is to keep them from falling if there is a fire in the building. This is to protect fire fighters and other folks in the building

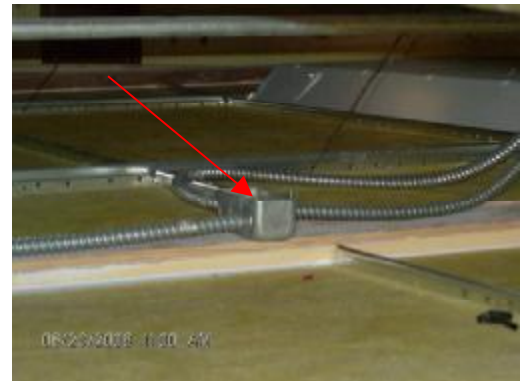
Safety Concern We found wiring junction boxes without covers. All wiring connections are required to be enclosed in approved equipment to reduce the risk of fire that could occur in the event of a fault that might cause sparking or over heating. While not urgent, this is a potential hazard that can easily be corrected by installing covers on the boxes. Location: above the lay in ceiling.

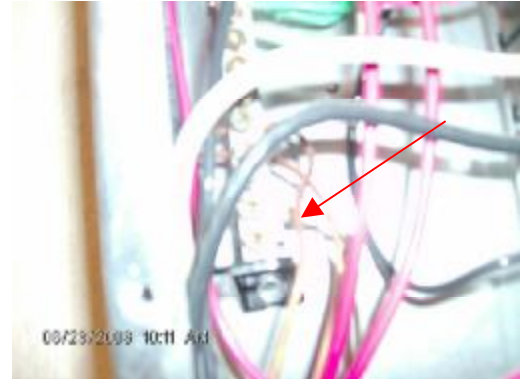
Safety Concern The neutral and ground conductors are improperly connected in the sub-panel(s). These are required to be isolated at any point beyond the main disconnect.. This is the lights in the back store room

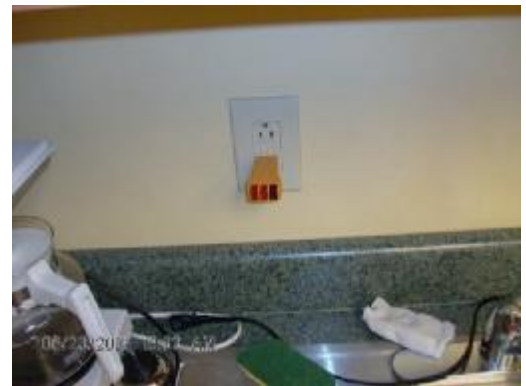
Safety Concern The ground fault circuit interrupters (GFCI's) at the kitchen sink does not work properly. When you plug something in the bottom part the power go out at the receptacle.

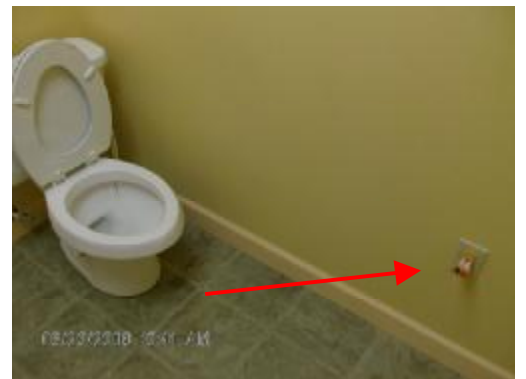
Safety Concern There are receptacles in the bathrooms that are not ground fault circuit interrupters (GFCI's) .All receptacles in the bathroom are suppose to be ground fault circuit interrupters (GFCI's).

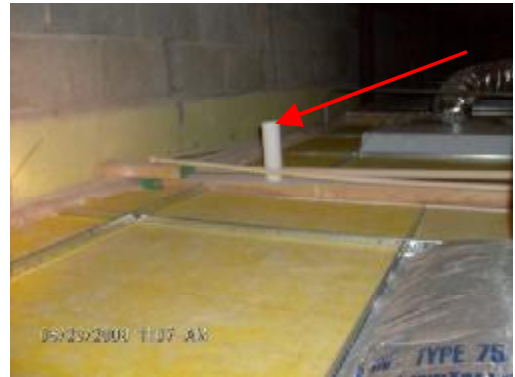
Investigate Further A plumbing vent pipe is discharging sewer gases into the attic. This can allow sewer gases to enter the house and can cause moisture problems in the attic. This pipe needs to be extended through the roof to eliminate these problems. A plumber should make the repair.

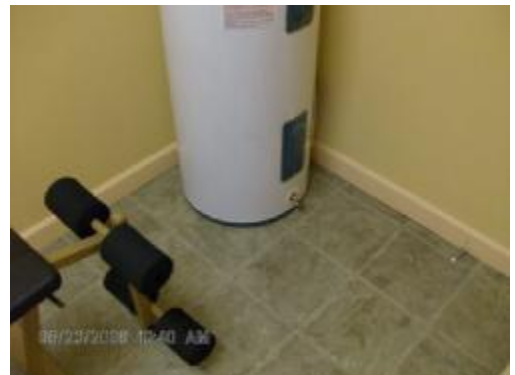
Investigate Further The water heater is not installed in a drain pan (as would be required in a new installation.) When it begins to leak, as all inevitably do, water will damage floor coverings.

Investigate Further The water heater is not installed in a drain pan (as would be required in a new installation.) When it begins to leak, as all inevitably do, water will damage floor coverings and walls.

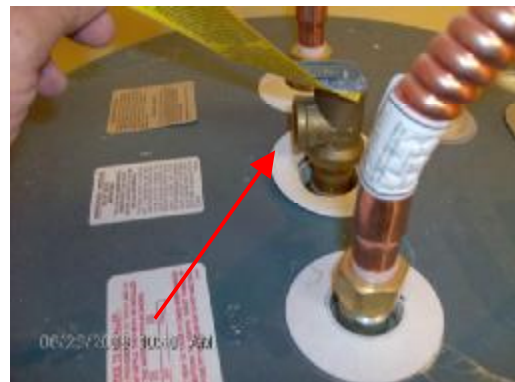
Safety Concern The water heater Temperature Pressure Relief Valve overflow pipe is missing. The pipe needs to be installed so the water will not spray on someone if there is ever a time that the Temperature Pressure Relief Valve releases and the water needs to be shut off at the water heater.

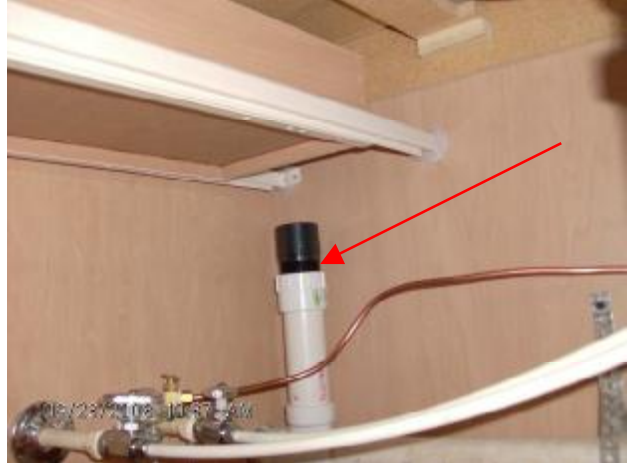
Minor Repair The wrong type of vent valve is being used to vent the drain at sink in the breakroom_. It is suppose to be air admittances valve not a mechanical vent.

Minor Repair The wrong type of vent valve is being used to vent the drain at sink in the break room. It is suppose to be air admittances valve not a mechanical vent.

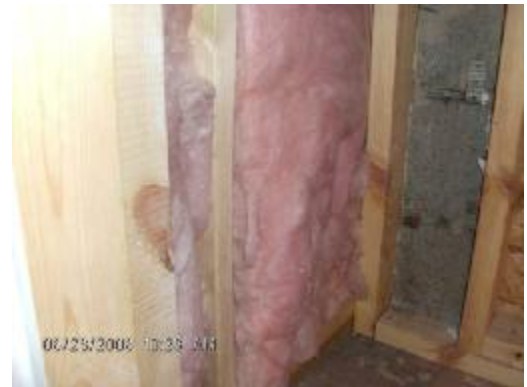
Minor Repair The l box under the air handler serves as part of the return duct system. The box is open to the walls on its sides. This allows air from the walls to be drawn into the

Minor Repair The l box under the air handler serves as part of the return duct system. The box is open to the walls on its sides. This allows air from the walls to be drawn into the system. Ideally, ductwork should be installed. At minimum any openings and joints should be sealed.

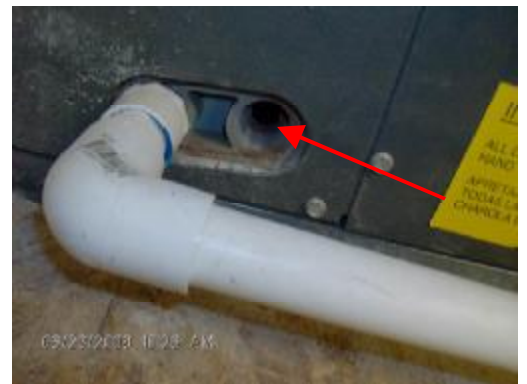
Minor Repair There are opening at the coil in the heat pump that is letting unfiltered air into the unit. This could stop up the coil. These areas need to be sealed off. Recommend that the system(s) be cleaned and serviced.

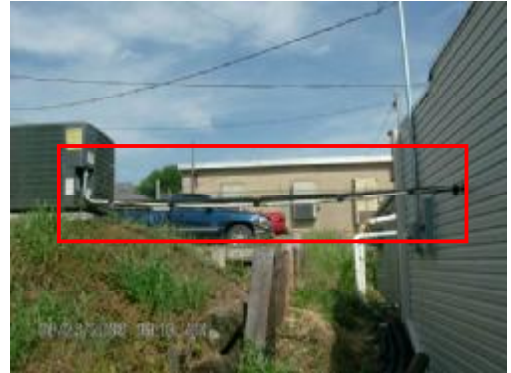
Investigate Further The line set and electrical conduit is just hanging in the air. It needs to be supported.

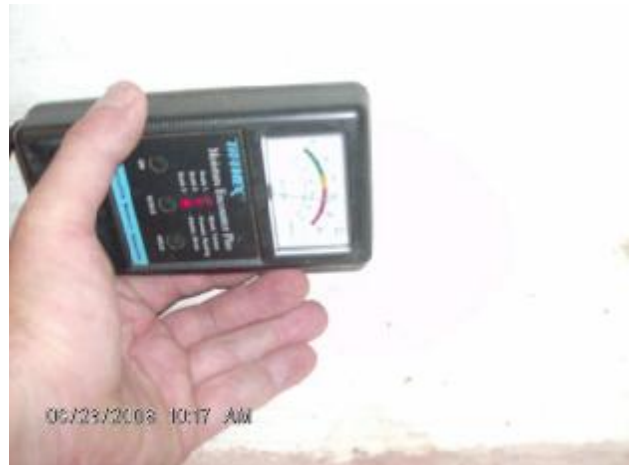
Investigate Further The wall at the rear left corner is showing a higher than normal moisture reading. The cause of the moisture needs to be found and repaired

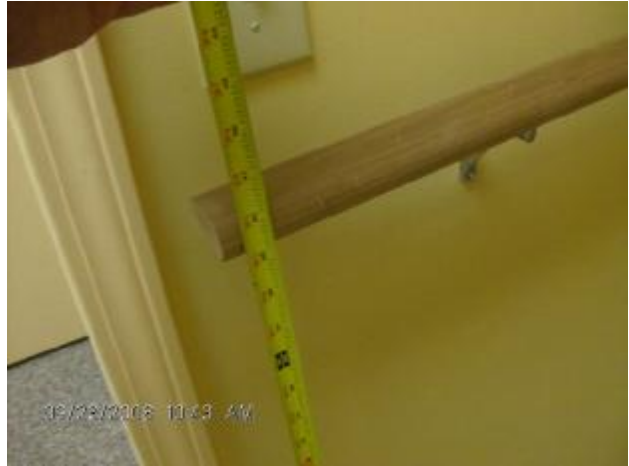
Safety Concern The hand railings at the ramp are too tall. They are supposed to be 34 - 38 inches from ramp. These are 40 inches
