Home Sweet Home Inspections

New Home Inspection Report Sample

Report Number: 051508

Address: 10 Austin Drive Wood AI 35118

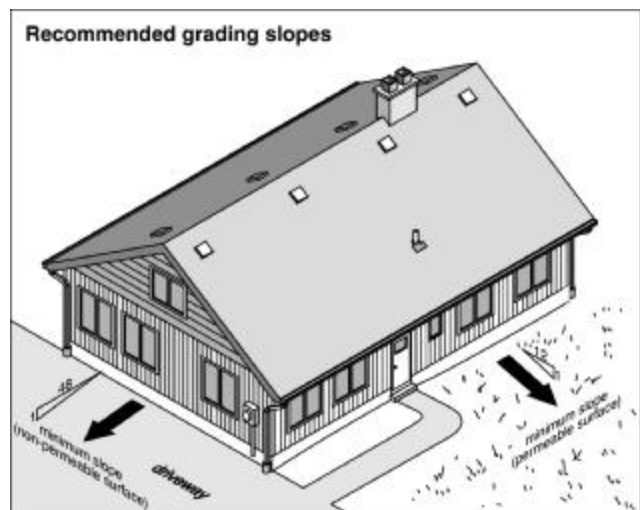
Grading is adequate in most areas. Minor adjustment is needed in some locations to divert water away from the foundation.
