Home Sweet Home Inspections

Sellers Home Inspection Report Sample

Report Number: 050608A

Address: 1625 Creek Drive Mudville Al. 35470

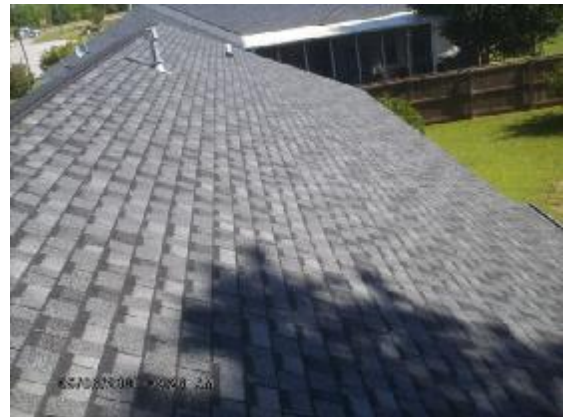
View of roof.

The roof flashings were observed. The flashings are in need of repair.

Based on the condition of the roof, we estimate that the roof is in the middle third of its typical expected lifespan.

Minor Repair There are areas that nails are backing out of the shingles. This is causing opening that could let water to get under the roofing and into the attic. The places that where seen is at the right side ridge of the roof.

Investigate Further There are areas that the shingles are not bonded/stuck to each other. They should be sealed down so the wind cannot get under them and be blown off.

Minor Repair Some of the ridge vents are loose and should be installed back in place to keep water from getting in.

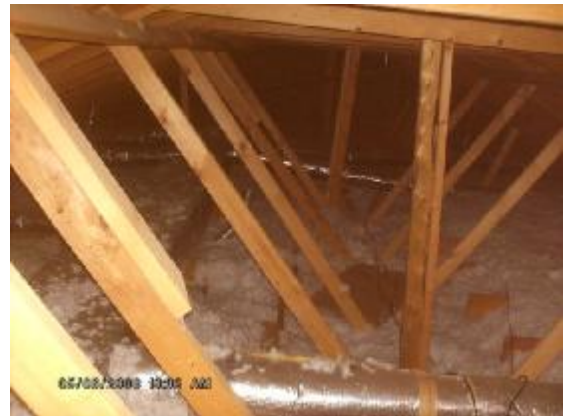
View of attic

Attic ventilation appears to be adequate.

Safety Concern The attic pull down ladder is installed in an unsafe manner. Attic access is installed with drywall screws. It is suppose to be installed with nails. (2) (4). The manufacturer's instructions recommend 16-penny nails or 1/4" bolts. **DO NOT USE THE LADDER UNTIL IT CAN BE MADE SAFE.**

Minor Repair The attic framing system has been altered/cut. This needs to be repaired since it supports the roof.

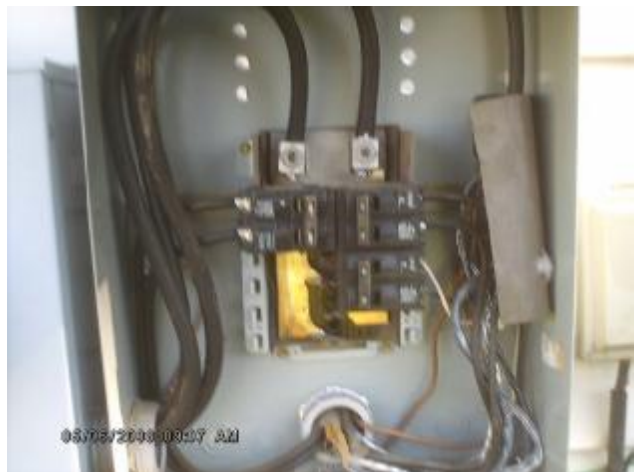
The 120/240 volt, 200 amp service enters the house from through conduit underground.

The service entrance wires are #4/0 aluminum.

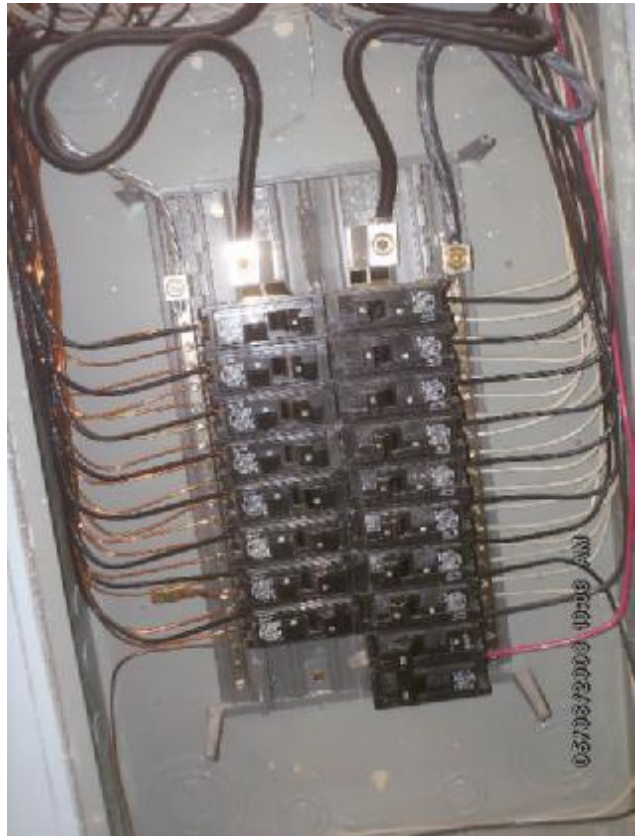
We opened and inspected all main and sub-panels.
Conditions appear adequate.

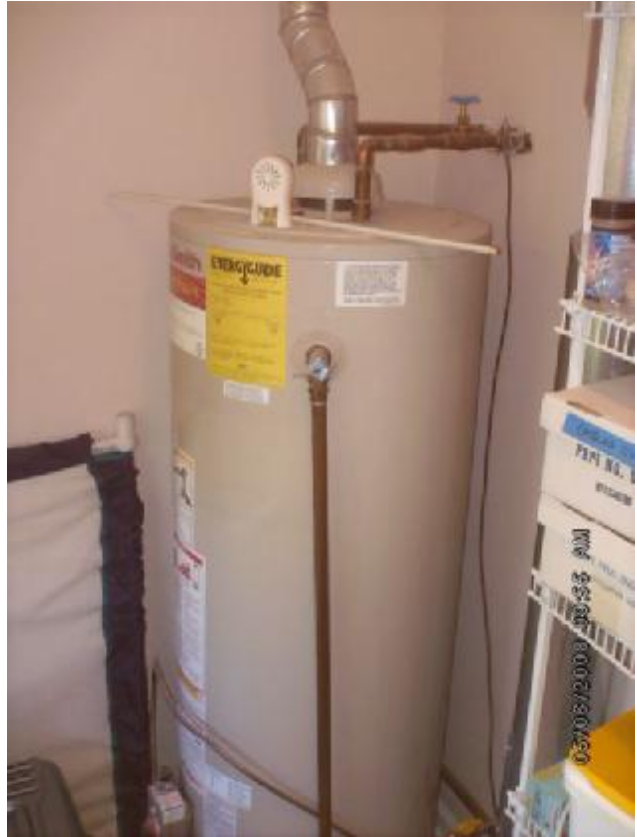
The gas 40 gallon primary water heater is located in the utility room We estimate the age of the water heater to be eight years old. A temperature pressure relief valve is present on the water heater.

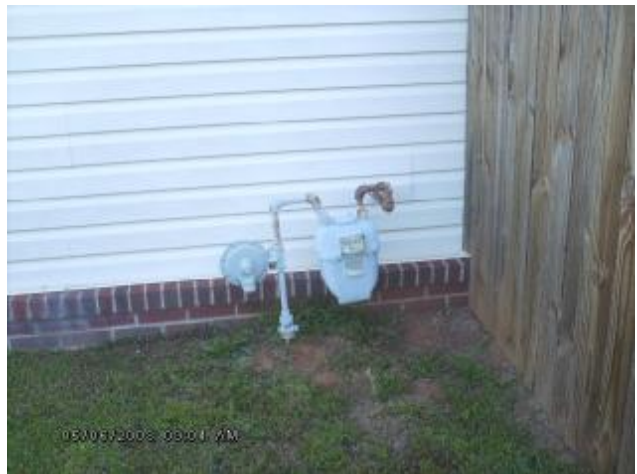
Fuel system appears to be in functional condition.

The readily visible fuel piping system appears to be in functional condition

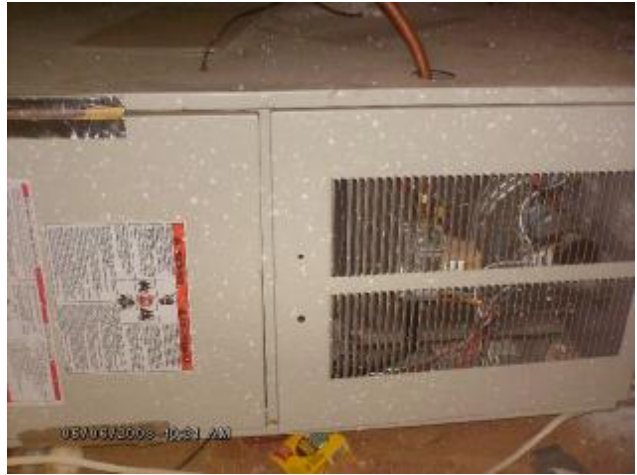
The heating system for the house located in the attic consists of a gas fired hot air furnace.

The heating system capacity is 100,00 BTU

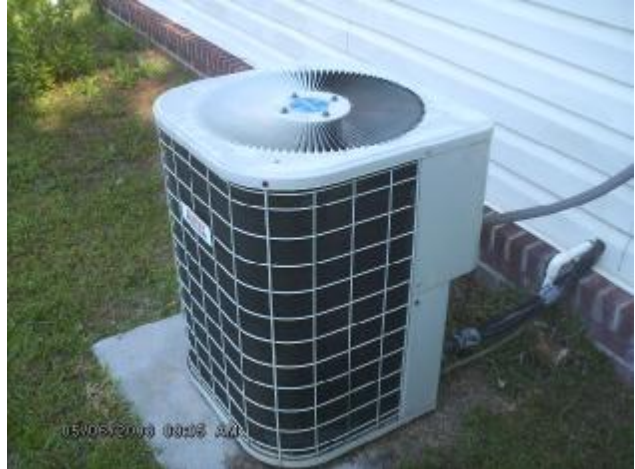
The central air conditioner was operated during the inspection using the normal operating controls. The temperature differential was measured and found to be 14. This is the number of degrees the system is cooling (or heating) the house air. Normal range for this number is 16-22 degrees when operating the system during hot weather, higher when ambient temperatures are lower.

The suction line at the air handler was found to be cold and sweating which is normal. The liquid line was found to be warm which is normal.

Coils in the condensing unit and air handler were examined and found to be in need of cleaning.
