Home Sweet Home Inspections

Building Inspection Report

Prepared For:
Small
Commercial
Office

Address: 1205 1st Street South AL.

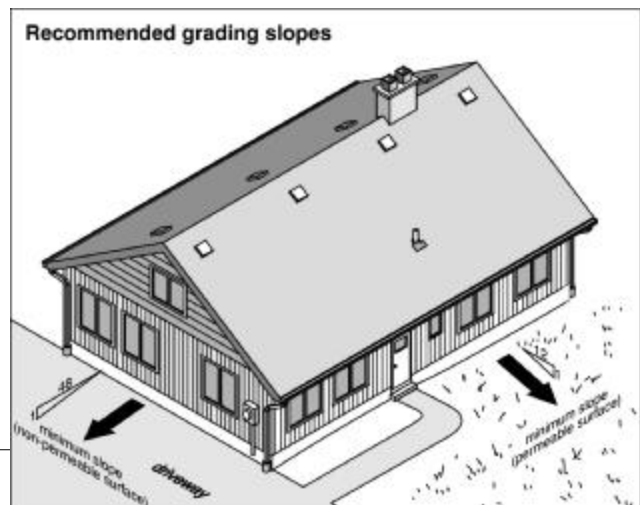
Grading is adequate in most areas. Minor adjustment is needed in some locations to divert water away from the foundation.
